INSPECTIONS OF STAINLESS STEEL TANKS & PIPE'S

LEAKS IN CARGO TANK LINES ON BOARD A CHEMICAL CARRIER

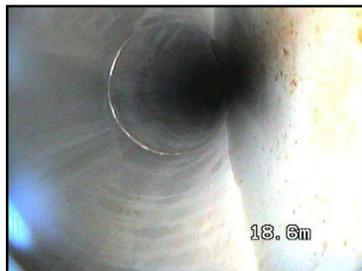
Line 1 – Extensive rust spots, most likely caused by free iron/oxides trapped on surfaces

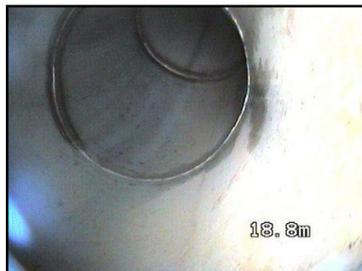
Line 2 – Evidence that at one time the piping had been half submerged in a pickling acid, with the lower half circle of weld seam pickled and the upper half circle untreated

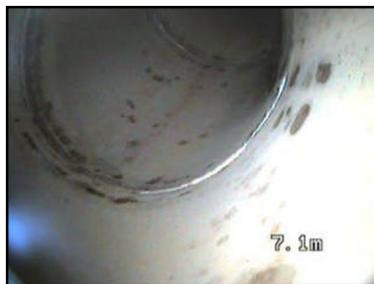
Line 4 – Extensive contamination, especially near weld seams, possibly caused by free iron/oxides trapped on surfaces

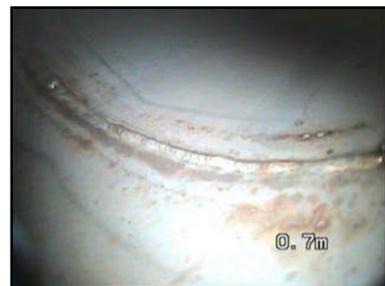
Line 5SB (before treatment) – Weld seams contaminated with significant corrosion products

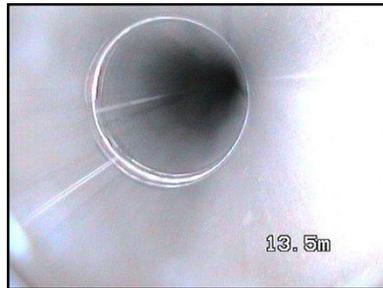
By maintaining a clean stainless steel surface, and by thorough removal of chlorides derived from seawater used for cleaning (using a thorough follow-up cleaning using fresh water) the opportunity that galvanic corrosion will occur is greatly reduced. Maintenance of clean and chloride-free surfaces cannot be over-emphasized when discussing the passivity of stainless steels. It is not possible to entirely remove all crevices or crevice-like phenomena. In such areas the possibility for corrosion exists. However by keeping the areas clean and exposed to oxygen, the stainless steel will maintain its resistance to corrosion over a prolonged period of time. The vessel experienced fewer cargo/ stripping line leakages either during pickling or during subsequent pressure testing with water than was the case for the other vessels to date. The overall condition of the welding when seen using the boroscope appeared better than that seen in reports on other vessels in the series. During the project on this vessel there was a need to trim the vessel more than 7m forward to expose the rudder for already planned essential repair. The consequence of this is that lines 4, 5P, 5SB and Slop could not be properly drained of liquid, since, unlike lines 1 and 2, there is no connecting line/ valve between the cargo line and stripping line where the cargo line tee is positioned at the manifold. We recommended, therefore, to allow for a proper drain of liquids from the other lines, a 1/2 " socket be added as indicated in this photo taken of line 4:

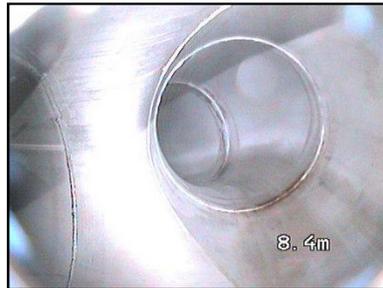
Line 1 (after treatment) – Cleaning and pickling successful

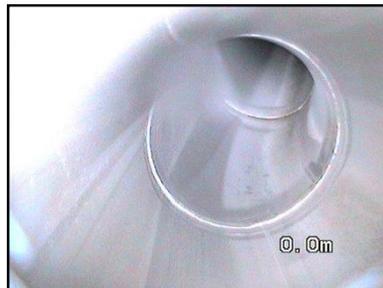
Line 4 (after treatment) – Pickling successful, some evidence of trapped air pockets caused by vessel trim

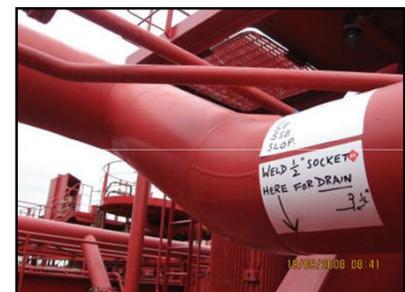
Photos and boroscope inspection of line 5SB – successful pickling
