THE PASSIVATION OF STEEL

The inside of piping made of construction steel must also be treated and protected. Depending on the application, there are several methods to apply temporary protection: phosphating, chromating and/or a chemical passivation. This Technical Bulletin gives more detailed information about the last method, the chemical passivation of construction steel.

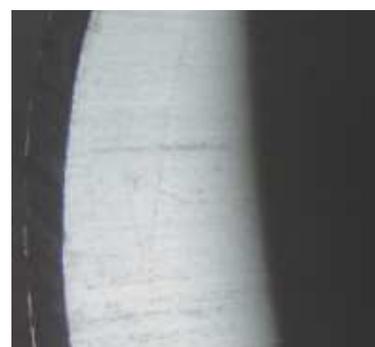
Fig. 1: various stages of rust of mill scales.

During the production process of construction steel, the intermediate product is generally made by milling, casting or forging. High temperatures are used in all these processes that, consequently, involve an associated oxidation process, resulting in the formation of various iron oxides. During the milling process, these oxides will be compressed to a compacted mill scale that consists of ferrous oxide, magnetite and haematite. Unfortunately, the mill scales do not remain intact, because as a result of the cooling contraction cracks are formed right down to the steel surface. Rust is formed in these cracks causing the steel surface to be attacked (see fig. 1).

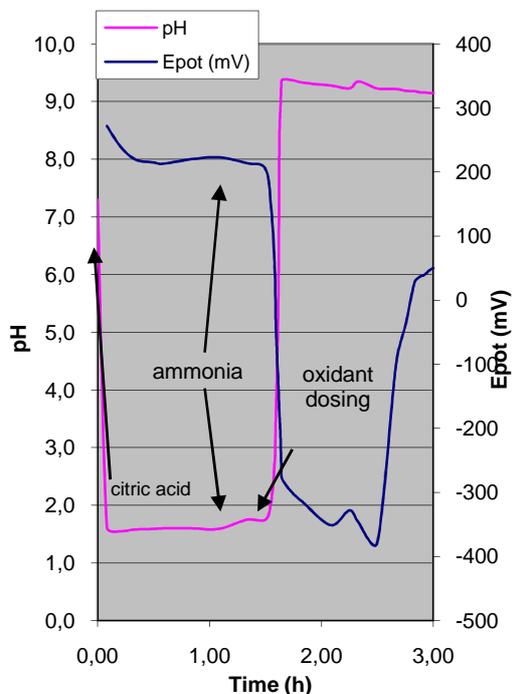
Graph 1: Passivation ammonium citrate typical plot

The use of citric acid is also necessary, because the solution is neutralised to an alkaline pH. Normally, the iron would precipitate due to the formation of iron hydroxide. However, as a result of the strong complex formation of iron with the citrate, the iron ions will remain in solution. The addition of an oxidising agent to the ammonium citrate will increase the potential of the solution. Hence, the passivation process is monitored by means of potential measurements (see graph 1). The passivation process is ready when the potential of the passivation liquid has increased sufficiently as the result of the addition of the oxidant. The gamma iron oxide film will then have formed on the steel surface. The passivation liquid can then be removed.

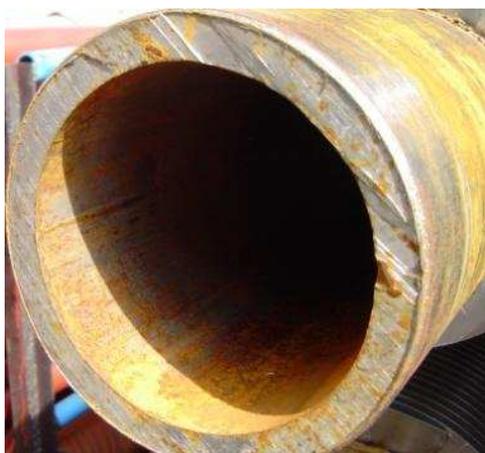
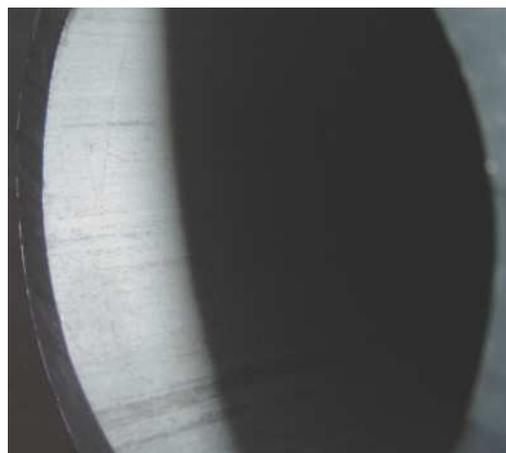
The result is a beautiful silvery grey passive steel surface.
